Jeremy Milln FSA.
Consultant for archaeological conservation

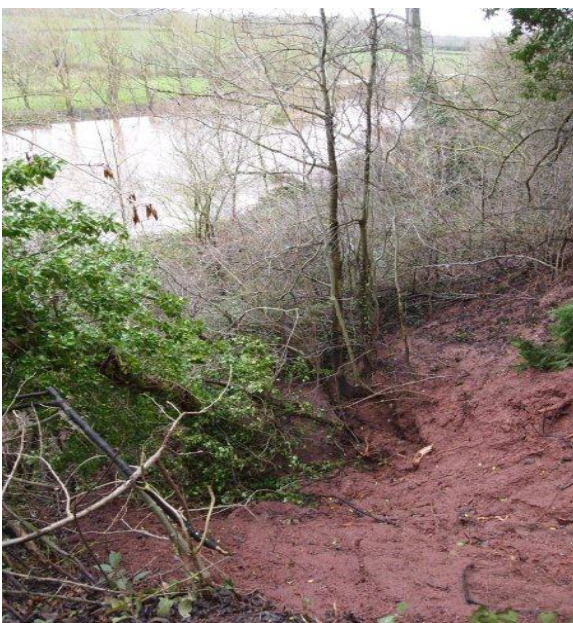
Fig 2: Landslip shortly after it occurred, 20th Dec 2012 (view from above)

- Fallen and damaged trees to be felled using a chainsaw and cleared by hand. This comprised a tall ash of moderate size (ring count 35 years) lying at an angle at the base of the landslip, a young sycamore and some elder. Three or four smaller sycamore were also removed using bow saws. Hawthorn and young elm present at the site was left.

- Slumped sub-soil material was excavated using a small tracked mechanical digger operated during a spell of dry weather while the flow of the Spring was low and the ground around firm, so as to avoid collateral damage.

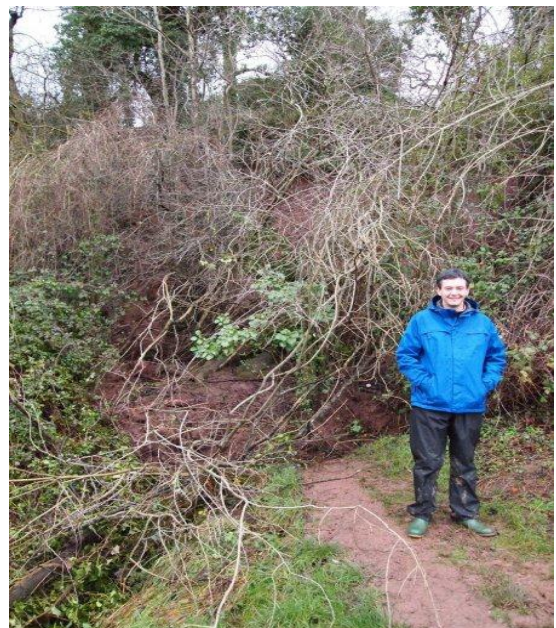
Below the site of the Spring a steep-sided gully, some 2.5 metres deep, had been formed by erosion during very wet weather. This gully had in summer become very overgrown so that it presented a concealed hazard to visitors.

Fig 3: The site in winter 2012/3
(view from the south)

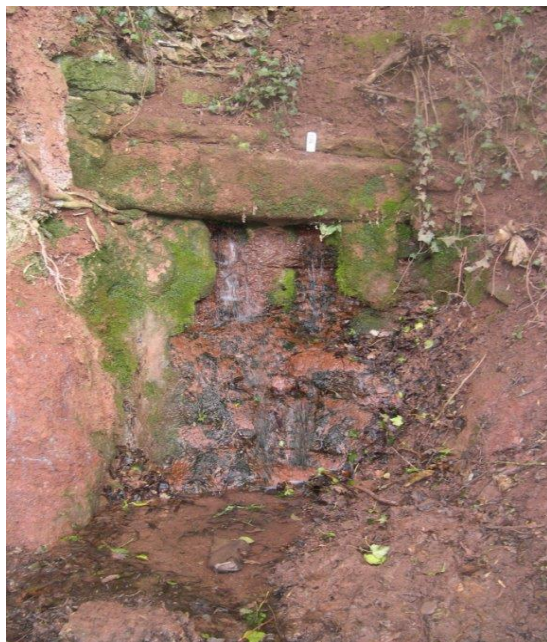
Fig 5: Spring before landslip, February 2011 (below)

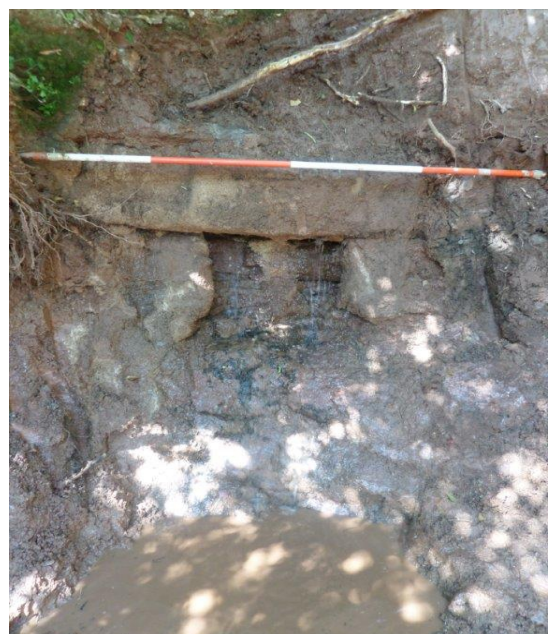
Fig 6: Spring after re-excavation, July 2015 (below r)

- Sub-soil and soil material excavated from the land-slip was used to form a causeway (see below) and to augment the bank areas to the west and south of the Spring. A small number of stones were recovered and these have been re-used to form a small step close to the Spring. Finally all areas of bare ground was seeded using wild fescue grass gathered from the adjacent pasture.

- Archaeological supervision was carried out throughout. The objective was to remove only the 2012 slumped material back to pre-existing levels and to fully restore visibility of the attractive spring feature itself. No finds of an 'archaeological' nature were recovered. However the opportunity was taken to remove and properly dispose considerable quantities of modern rubbish and litter.

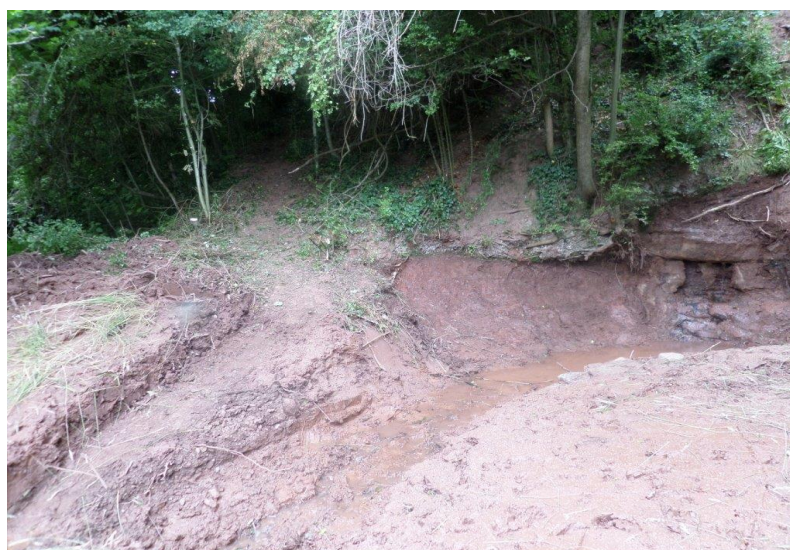
Fig 6: General view of site after re-excavation with the Spring to the right and the West Path to the left
20th July 2015

A causeway was formed to allow dry, safe access to both sides of the Spring where access had latterly been only to its east side. This was done using cordwood log and brash from the tree work placed at the base the erosion gulley close to the Spring. Arisings from the excavation were placed on top of this and layered with further brash to resist slumping and to 'filter' muddy water before entering the river. A 'pipe' was formed using a quantity of cordwood set together vertically so as to take the surface water of the Spring to the now buried cordwood drain under the causeway. The idea of the causeway is not to pool the water of the Spring, rather to allow it to drain away underneath in a controlled manner as well as improve access at the site generally.

Latterly it has been possible to approach the Spring only from the east so that visitors have had to double back to the track. Until about ten years ago it was possible to approach it from the west as well along a well-marked, if steep, path through the woods. This made the Spring part of a short circular route; a point of interest along its way. This had however become impenetrably overgrown with bramble and hawthorn. The opportunity was taken to clear the bramble etc and the path can now be used again.
